Dam Removal and the Salmon River Mussel Community

John E. Cooper

The Fort Covington Dam was an abandoned run-of-river dam on the first riffle of the Salmon River in northern New York (Fig. 1). The dam was removed in June, 2009, 96 years after construction

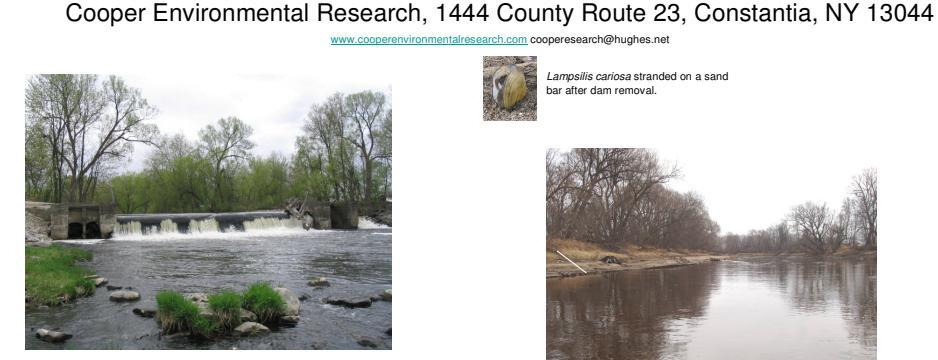
The Fort Covington Dam as it appeared in May, 2009 (upper panel), and during removal in July (lower panel). The dam was removed using a hydraulic hammer and excavator.

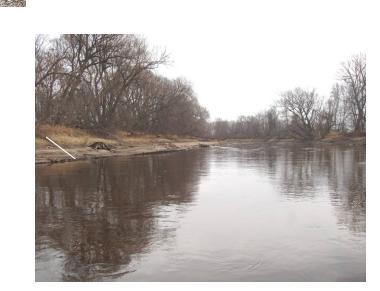
Lampsilis cariosa stranded on a sand bar after dam removal

One source of mussel mortality was stranding when the reservoir was drained. An example of the extent of exposed former habitat can be seen in the photo above (white line). This habitat accounted for 30% of the former reservoir area but was home to 97% of the reservoir mussels. Photo taken in November, 2009.

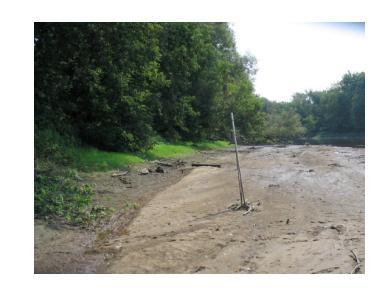
The pipe above (transect 6) contains the water level and water temperature sensors that recorded the rapid decline of water in the reservoir. Water depth prior to dam removal was 103 cm and there was no sand bar present. This sand bar formed rapidly after 2.7 cm of rain in July, 2009, and was 151 m in length, 8.5 m wide, and 61 cm deep (770 m3 in volume).

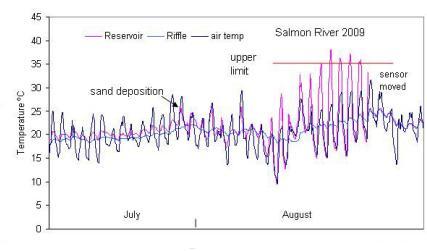
Sand deposition at the transect 6 water level sensor provided an estimate of the temperature that stranded mussels would experience in the exposed areas of the reservoir. Temperature exceeded the upper limit for mussels on five occasions and lasted for 4 to 6 hours during each event. The sensor was buried approximately 23 cm below the sand surface, similar to where mussels could be found. A similar effect can be seen at the transect 7 sensor (riffle) starting in mid August (Fig. 5) as sand was deposited over the sensor but to a lesser amount.

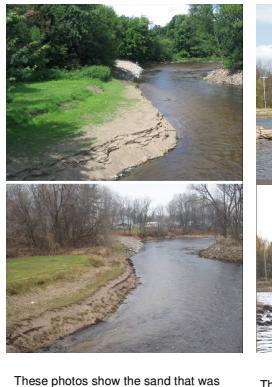
Where did the sand come from? There is a glacial moraine upriver at Malone that is primarily coarse sand and sand from there had been trapped by the dam over the past 96 years. The slower water velocity within the reservoir promulgated six sand bars that were mobilized during dewatering. The erosion of the newly exposed sand bars was accelerated by rain events. Two of these sand bars can be seen in the photos below.

seen to the right in the upper photo.

and the lower photo was taken in

November, 2009
