**Monitor Mills Dam Modification
State Environmental Quality Review Act
Long Environmental Assessment Form
Part 1D. Informational Details
Final Report, July, 2007**

**Monitor Mills Dam Modification
State Environmental Quality Review Act
Long Environmental Assessment Form
Part 1D. Informational Details
Final Report, July 2007**

Prepared by John E. Cooper for The Nature Conservancy, Central and Western New York Chapter

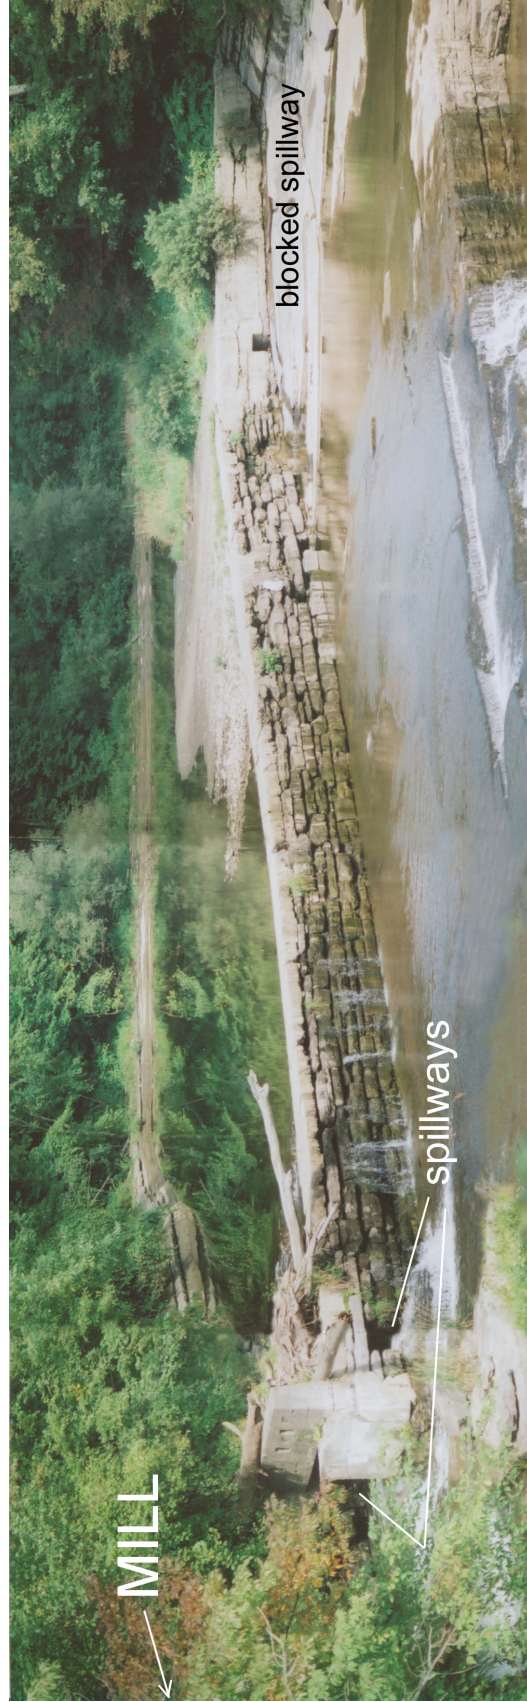
Figure 2. Monitor Mills Dam viewed from downstream on 7 September 2006. Discharge in Sandy Creek was about 30 cfs on this date. The mill was located about 220 feet downstream from the dam.

Characteristics and physical dimensions. The dam is a run-of-river gravity dam constructed of cut stone laid up with little or no mortar, capped by concrete, and extends 5–9 feet above the bedrock of the creek. The main structure extends 211 feet from the east bank of the creek in a SE direction where it abuts a second wall at a 65 degree angle, forming a point. This second wall contains the main spillway and extends out about 30 feet from the SW bank. The original dam configuration had the present point connected to a masonry flume wall that led southward to the mill, about 220 feet downstream (*see Attachment 1*).

The present dam retains most of the original structure with the exception of the masonry wall leading to the mill. The junction of the main dam and the wall from the SW bank (the present point) has been repaired with concrete. There are two auxiliary spillways, one near the east bank, now blocked, and the other near the point. The dam was considered to be in satisfactory condition according to inspections in 1917 and 1975. There were numerous leaks (September 2006) through the laid stone section of the dam and some of the stone had collapsed at the east end. The dam was considered to be a low to medium hazard in 1975.

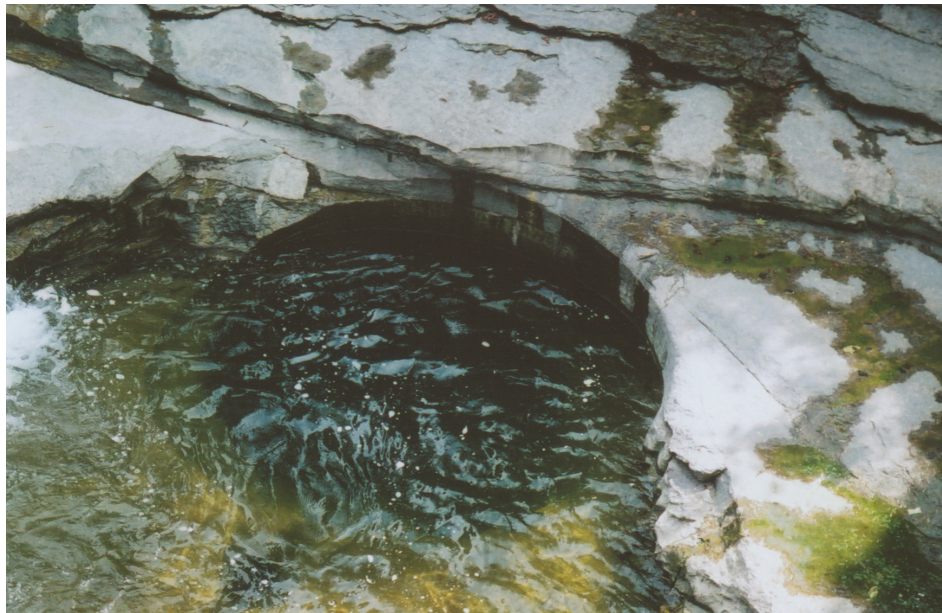
Figure 3. Geologic pothole formed by a subglacial stream in bedrock of South Sandy Creek. This pothole has a diameter of approximately 3 feet. Numerous potholes are present downstream of the Monitor Mill Road bridge.

2.1 Regional setting. South Sandy Creek flows southwest through Lorraine Gulf, a gorge of the Lake Ontario lowlands, into North Colwell and Goose ponds prior to entering eastern Lake Ontario. Most streams in this drainage basin (Salmon-Sandy, USGS hydrologic unit 04140102) flow through gorges, locally called 'gulfs', and have substrates of bedrock, cobble, and gravel. South Sandy Creek is on the border of two distinct Ordovician sedimentary deposits: the limestone, chert, and shale of the middle Ordovician period (streams to the north), and the overlying siltstone and shale of the late Ordovician (streams to the south). One distinctive feature of South Sandy Creek is the numerous potholes found in the bedrock of the creek that were formed by fast-flowing subglacial streams (Figure 3; Embleton and King 1971; Rogers et al. 2000).

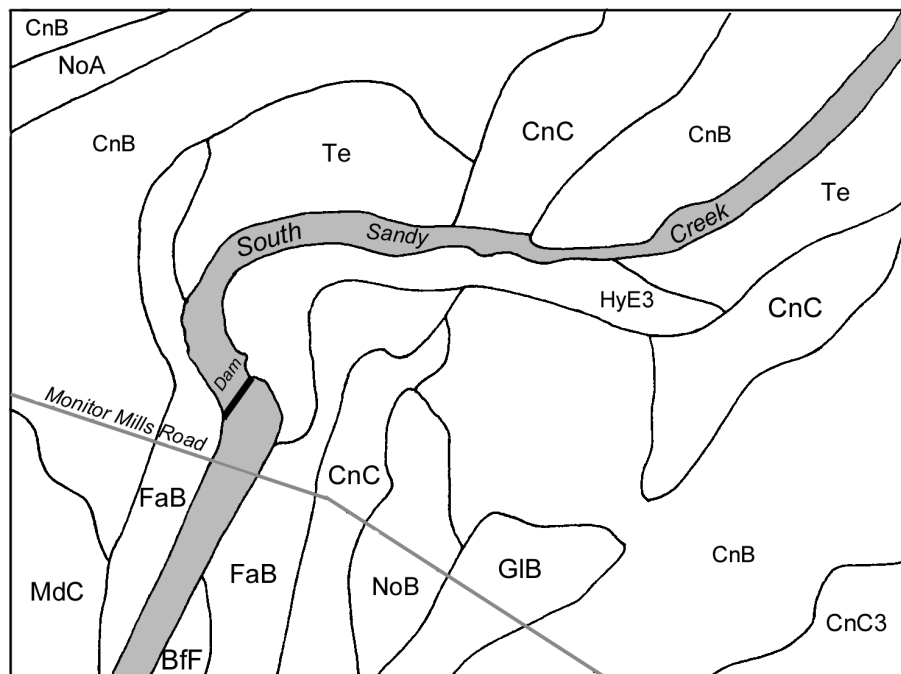
Figure 4. Soil types within the surveyed area. There are 94 acres represented in the surveyed area. These data are derived from the Natural Resources Conservation Service web soil survey (<http://websoilsurvey.nrcs.usda.gov>).

2.3 Soil types. Thirteen soil types are present in the surveyed area dominated by collamer silt loam. Only six of the 13 types occur next to the creek bank; the most prominent type is the severely eroded Hudson and Vergennes soils (Figure 4). Most of these soils are silt and sand with little clay, particularly those that border the creek bank (BfF, FaB, HyE3, and Te). The majority of these soils are moderately well-drained.

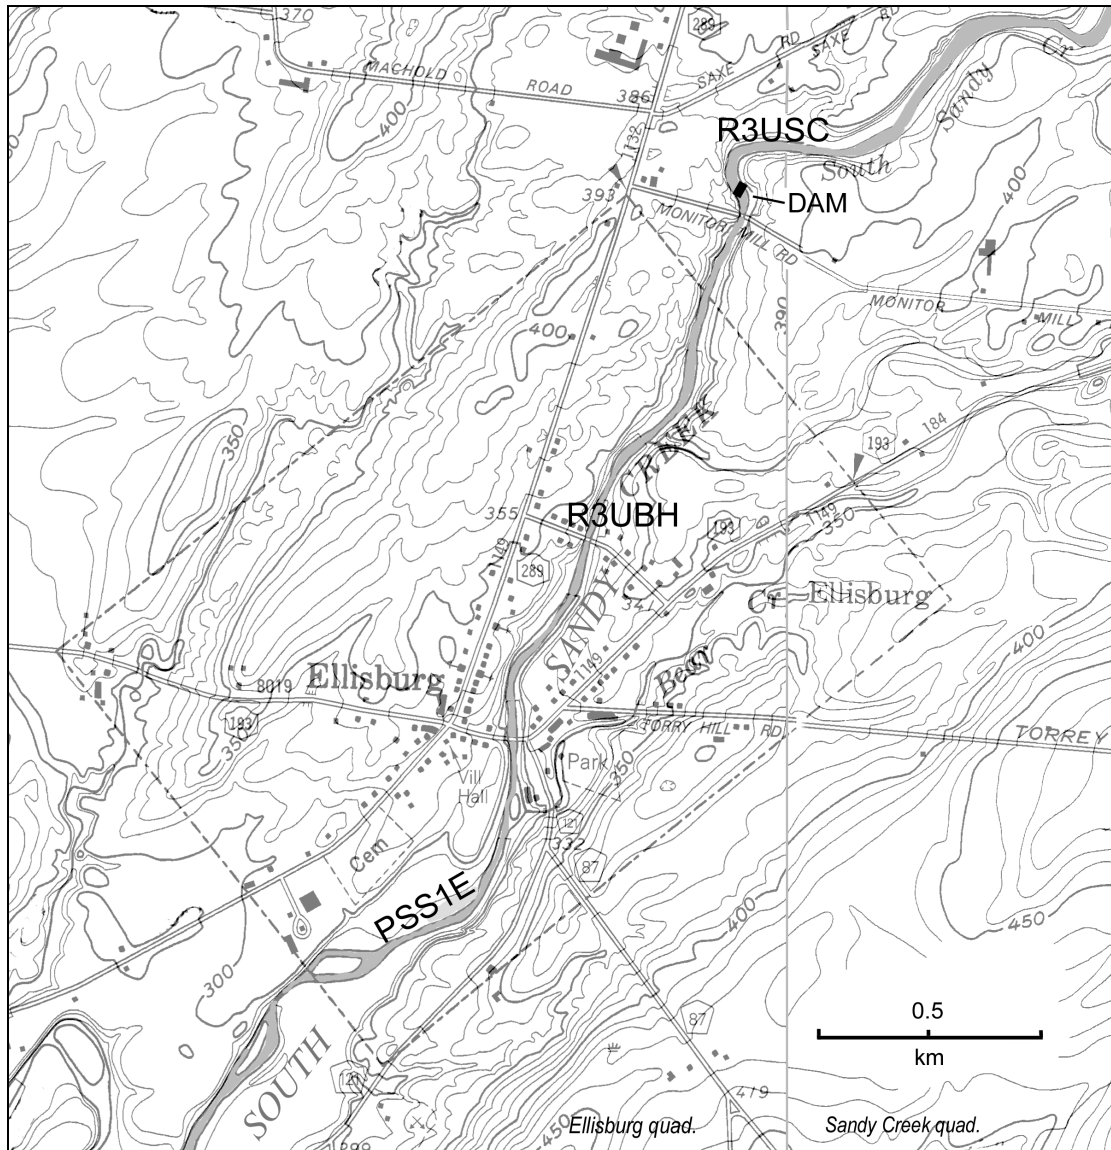
Figure 5. Topographic contours of the Monitor Mills Dam area and wetland designations. The dashed line represents the Ellisburg village boundary. Attribute classification definitions derived from Cowardin et al.1979. Base map from NYSDOT topography with wetlands derived from USFWS National Wetland Inventory (www.fws.gov/nwi).

2.4 Wetlands. The wetland designations for the area consist of permanently flooded substrate composed of cobble, gravel, and bedrock downstream of the dam to beyond Ellisburg and upstream of the dam to the first falls at Saxe Corner. Seasonally flooded unconsolidated depositional material has formed a shoreline behind the dam. Seasonally flooded scrub-shrub and broad-leaved deciduous plants are present approximately 2.2 miles downstream of the dam (Figure 5). Other wetland areas (not shown) occur in the upper reaches of Taylor Brook and Bear Creek, upstream and downstream of the dam, respectively.

The wetland designations shown in Figure 5 are defined as follows:

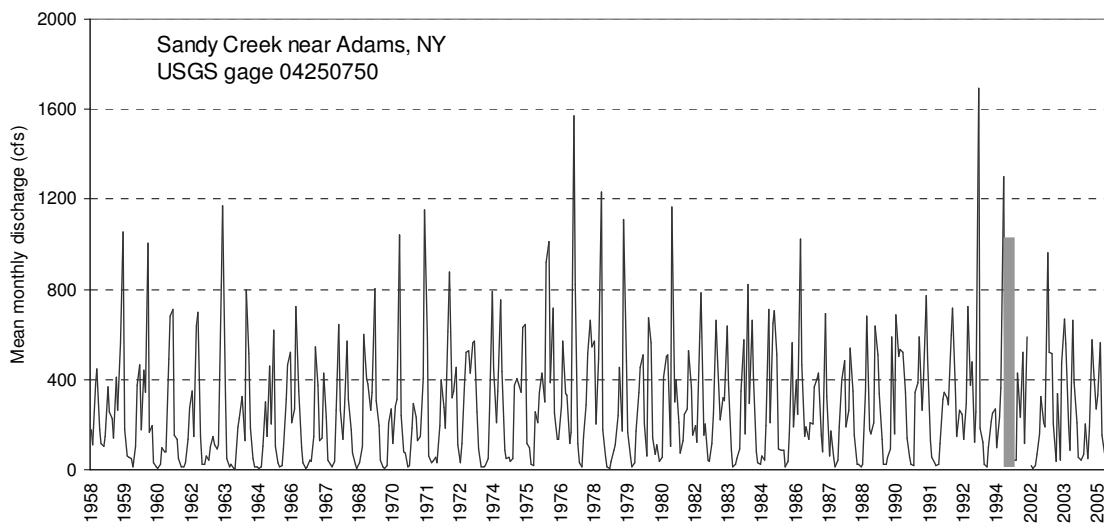
Figure 6. Mean monthly discharge by year in Sandy Creek from 1958 to 2005. The gray area represents April 1995 to June 2002 for which there is no discharge record. The flow pattern for South Sandy Creek is likely to be similar.

There is no gaging station on South Sandy Creek so estimates of water discharge have been made using the gaging station on Sandy Creek (USGS gage 0420750) near Adams: records for estimated daily discharge are poor due to influences from upstream uses so only average monthly discharges are shown. Seasonal and yearly discharge patterns in South Sandy Creek are likely to be similar to those in Sandy Creek. Flow in Sandy Creek indicates a flashy nature over the period of record (1958 to 2005; Figure 6), particularly during spring snowmelt and rain storms. The flashy nature of the discharge

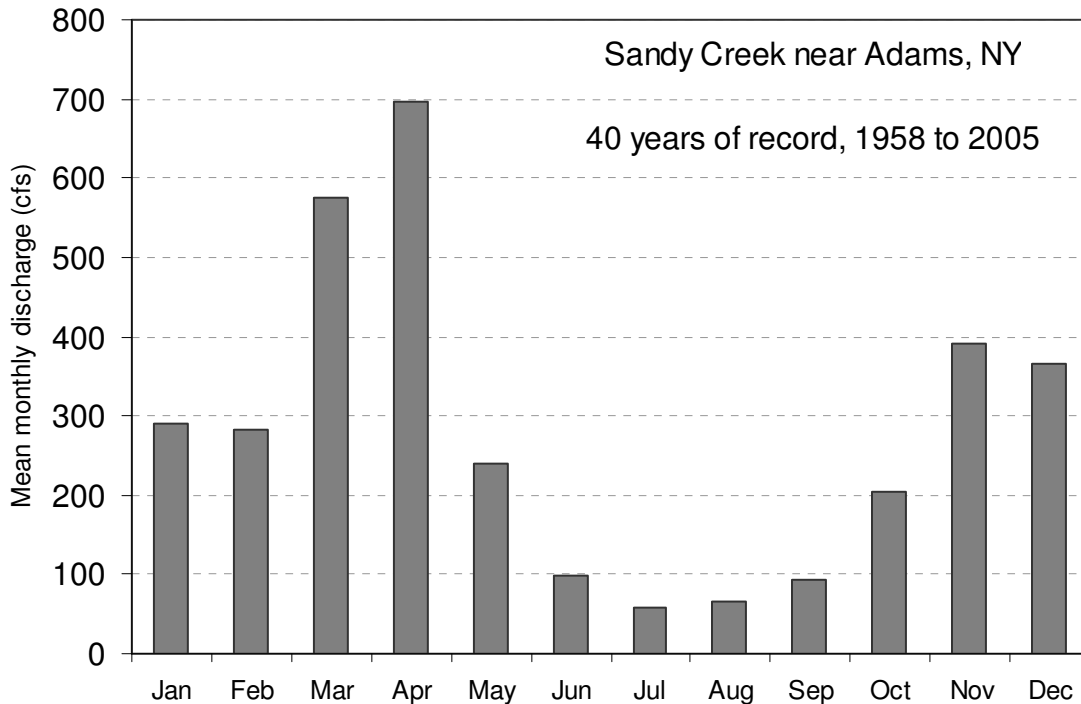
Figure 7. Mean monthly discharge in cfs (all years combined) for the period of record.

The mean monthly discharge by month (Figure 7) shows increased discharge during spring and fall months and a lower discharge during summer months. These average flows exceed the minimum flow needed for maintenance of trout and salmon populations (1-5 cfs), although minimum *daily* flow may not meet the minimum flow, especially during droughts.

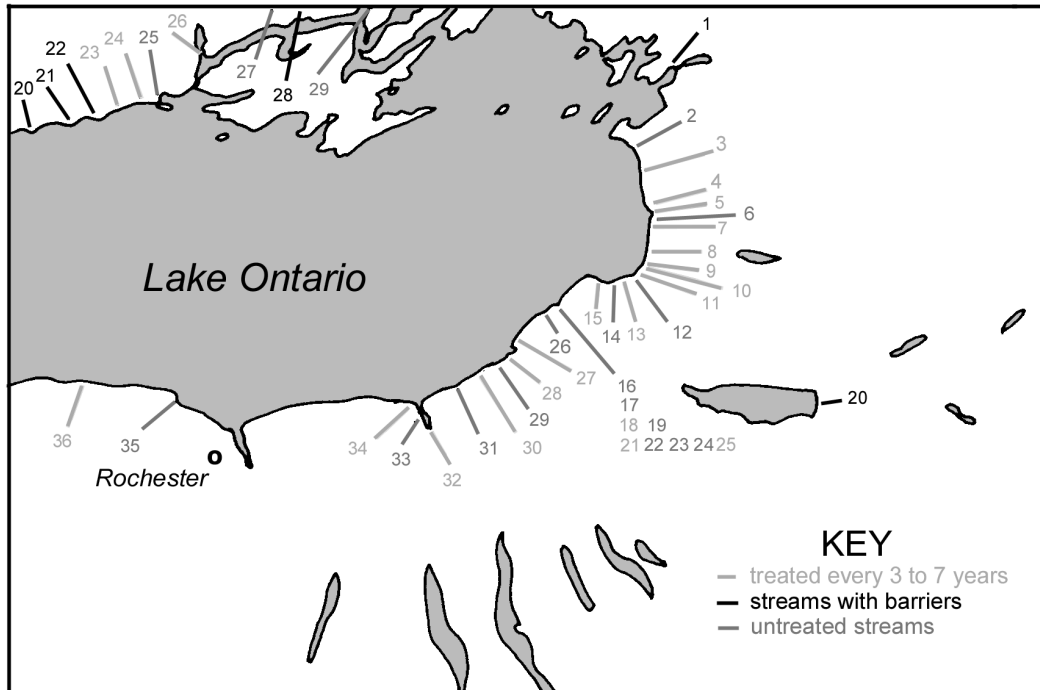
Figure 8. Sea lamprey stream management status for the eastern Lake Ontario drainage basin (map redrawn from Great Lakes Fishery Commission).

Sea lamprey is present in many streams in the eastern basin of Lake Ontario. These streams are shown in Figure 8 with their management status (www.glfc.org). South Sandy Creek is treated with TFM (3 trifluoromethyl-4-nitrophenol) lampricide at 3 to 7 year intervals for adults and larvae. Treatment started in 1972 and the most recent treatment was in May, 2005. A quantitative survey of South Sandy Creek downstream of the dam was made in 2004 and resulted in a population estimate of 1,815 transforming lampreys, and 154,485 larvae. Sea lamprey composed 4% (by number collected) in the NYSDEC data base (1986-2005). Surveys upstream of the dam have not been made since 1992, however, less habitat for sea lamprey larvae is available upstream of the dam and no sea lamprey larvae were collected when upstream surveys were made (F. Neave, pers. comm., Dept. Fisheries and Oceans, Canada). There has been no evidence of downstream migration of sea lampreys from upstream of the dam. South Sandy Creek will be surveyed again in 2007 with a possible treatment in 2008.

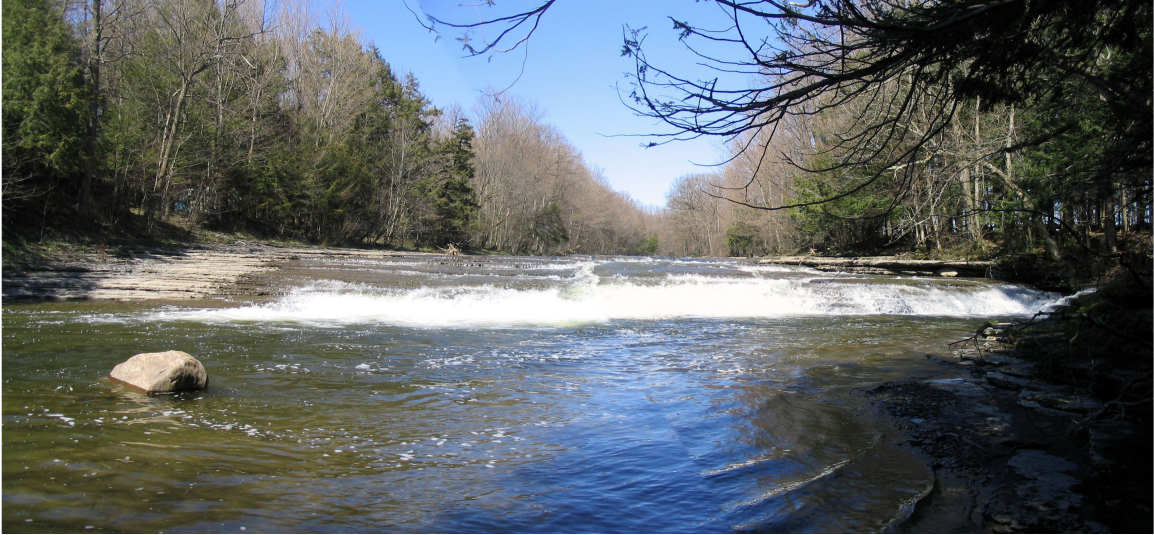
Figure 9. First falls upstream from Monitor Mills Dam. Photograph taken on 4 May 2007.

Two waterfalls are present upstream of the dam: upstream of Saxe Corner, and upstream of Wardwell Settlement Road. These falls would *not* deter sea lamprey from moving upstream. The first falls are located approximately 0.5 mile upstream from Saxe Corner and Log London Road (Fig. 9). The falls is arranged in a stair-step fashion of 1 to 1.5 foot increments and an overall height of approximately 6 feet. Sea lamprey could navigate upstream over the full length of the falls.

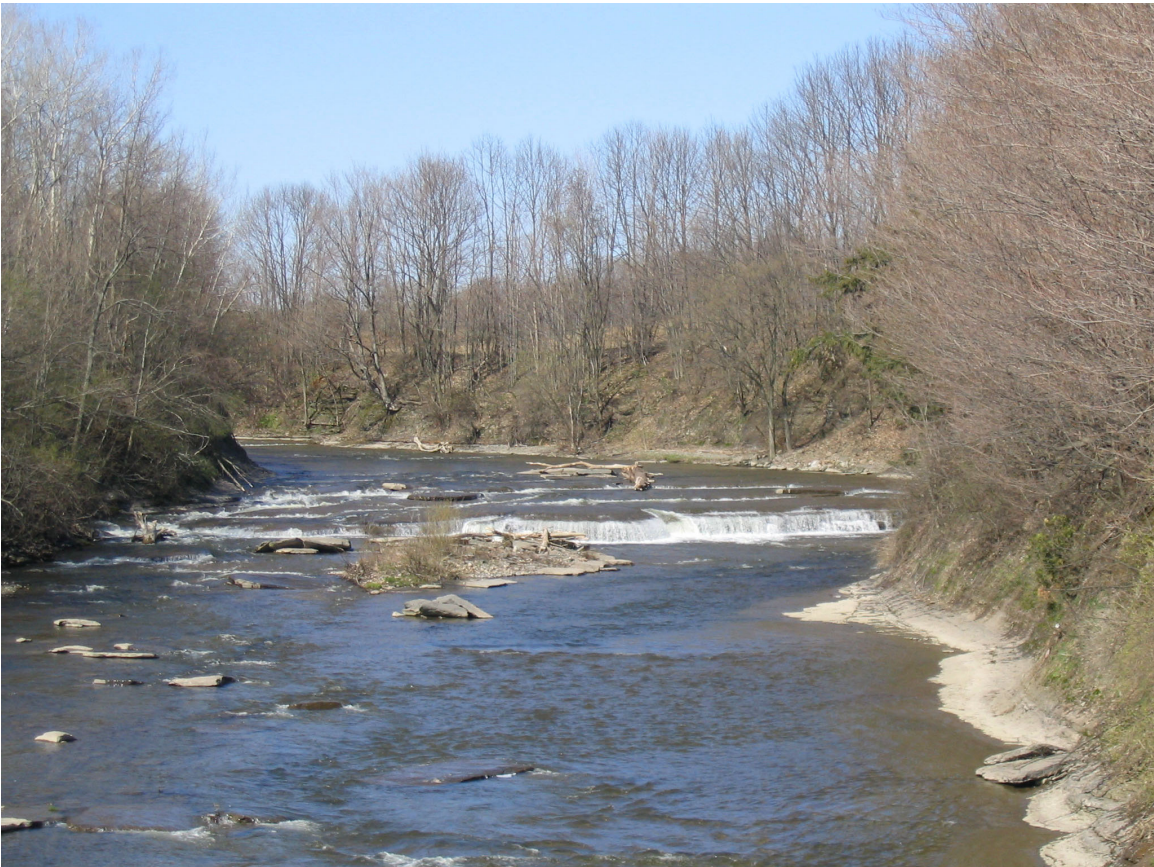
Figure 10. Second falls upstream from Monitor Mills Dam. Photograph taken on 4 May 2007.

The second falls is located just upstream of the road bridge at Wardwell Settlement Road, approximately 1.2 miles upstream of the first falls (Fig. 10). The second falls is approximately 3 feet in height and has a similar configuration as the first falls.

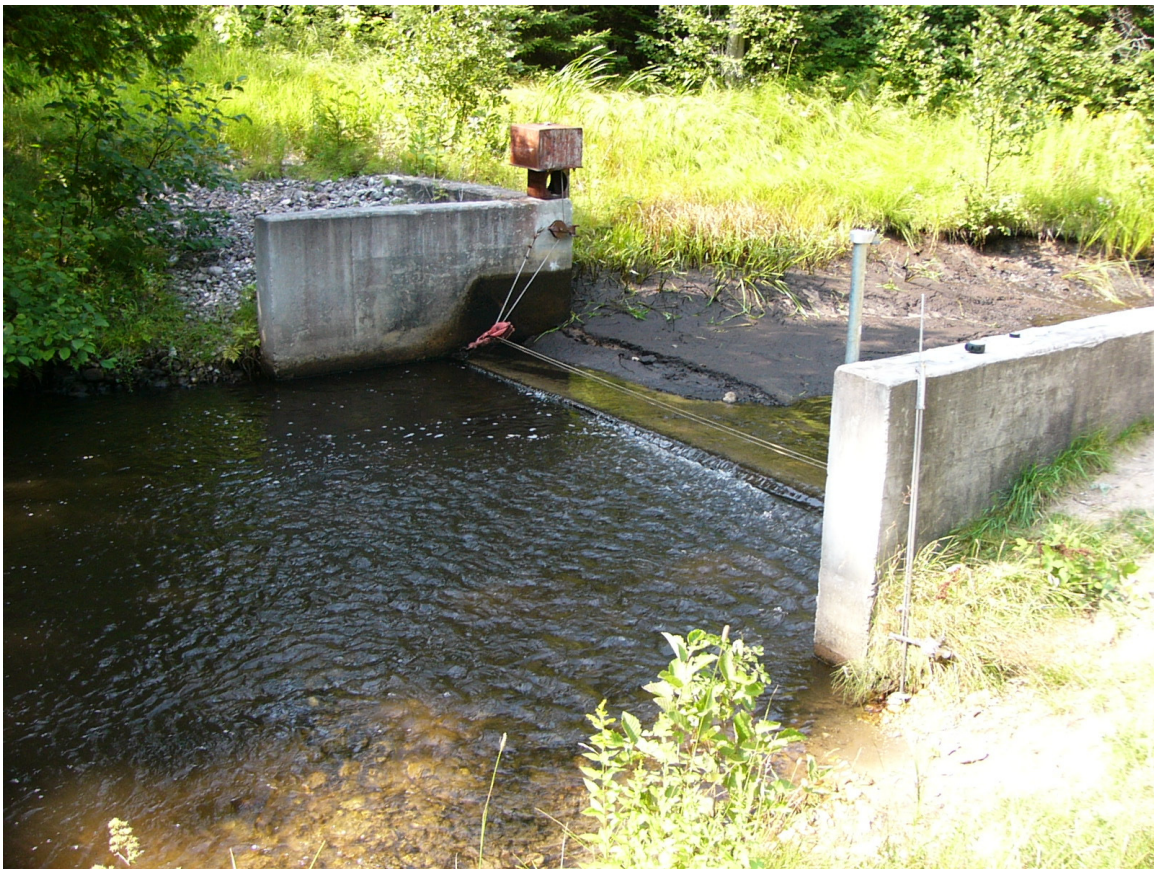
Figure 11. Mechanical lift gate with gate in down position. This type of barrier could be installed, with modifications, at Monitor Mills Dam.

Two other types of barriers were suggested: lift gates (Figure 11) and aluminum stop logs (Figure 12). These can be installed for approximately \$1000 and require less maintenance for successful operation. They do require manual inspection and monitoring for water level. Inspection would be required for spillway clearance of debris so this would not add to the overall cost.

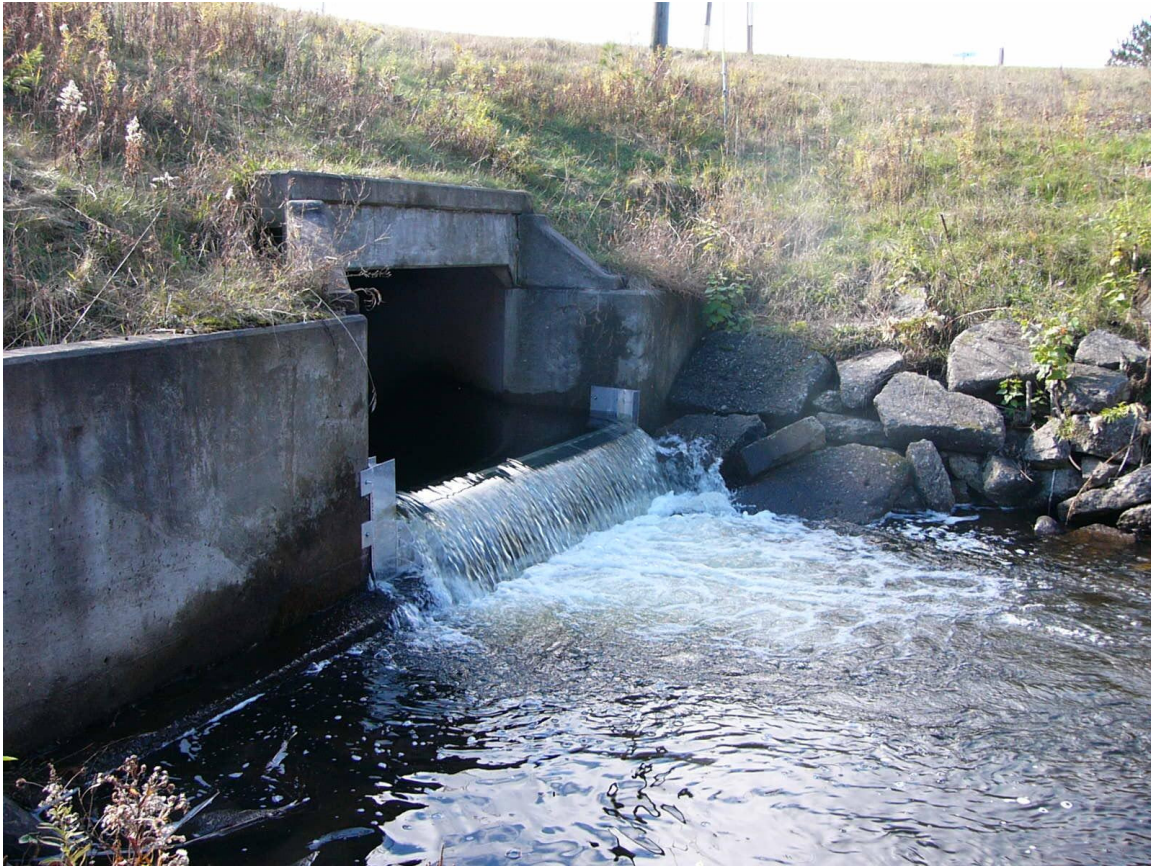
Figure 12. Adjustable aluminum stop logs set into the concrete as a lamprey barrier that allows for fish passage.

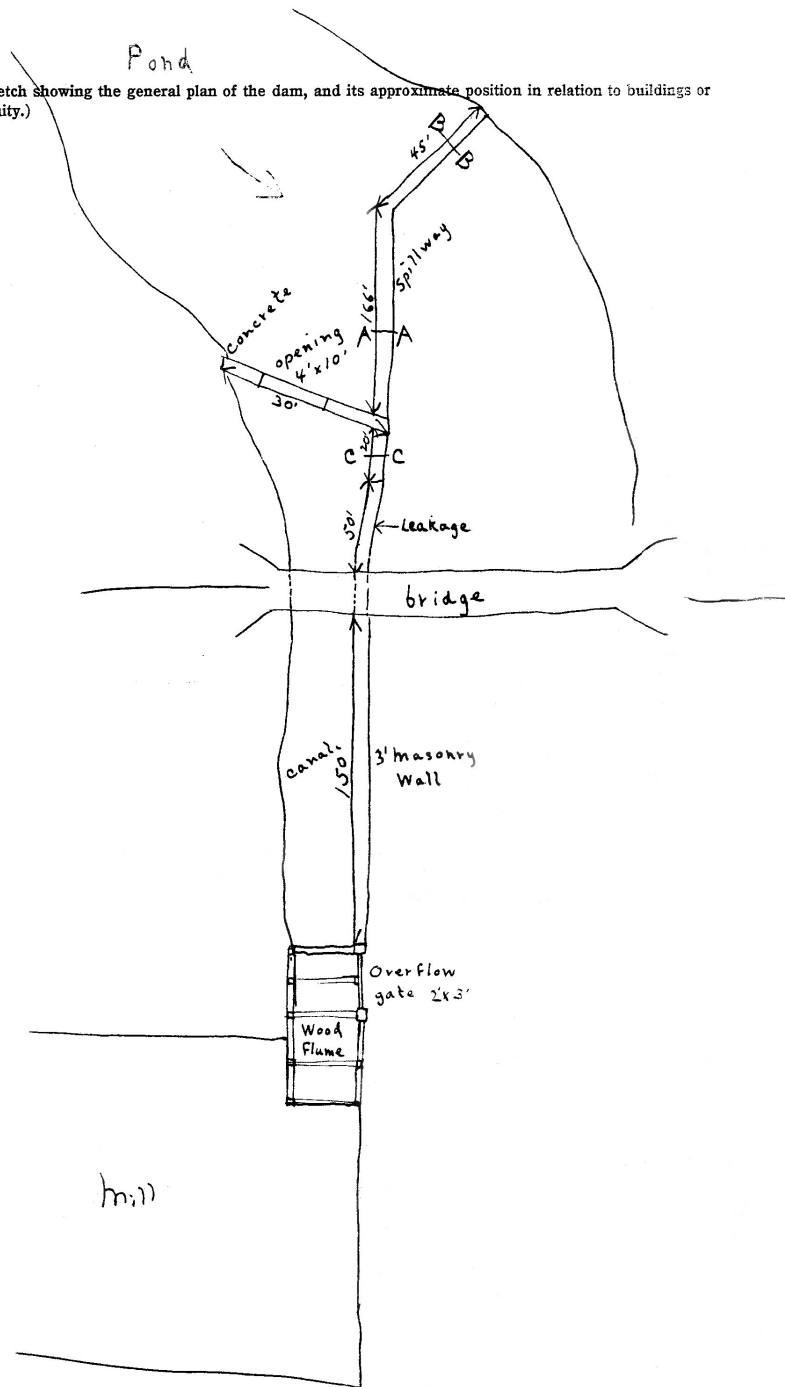
(In the space below, make a third sketch showing the general plan of the dam, and its approximate position in relation to buildings or other conspicuous objects in the vicinity.)

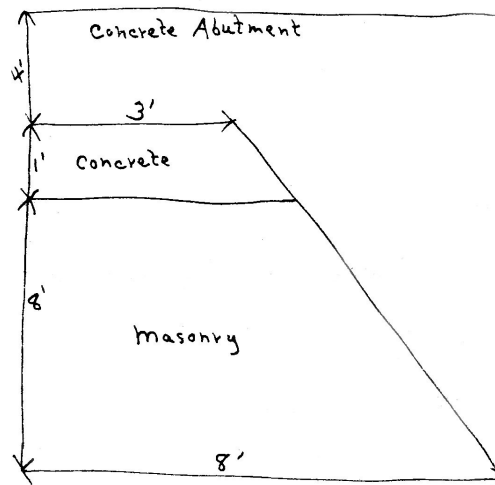
Section A A

(In the space below, make one sketch showing the form and dimensions of a cross section through the spillway or waste-weir of this dam, and a second sketch showing the same information for a cross section through the other portion of the dam. Show particularly the greatest height of the dam above the stream bed, its thickness at the top, and thickness at the bottom, as nearly as you can learn.)
